Monitoring Data Record

Project Title: I-540 Northern Wake Expressway (R-2000AB) COE Action ID: 200021863

Stream Name: UT to Kit Creek DWQ Number: 030918

City, County and other Location Information: Wake County, Site 6 (Sta.10+41 to 12+76 YRPA-)

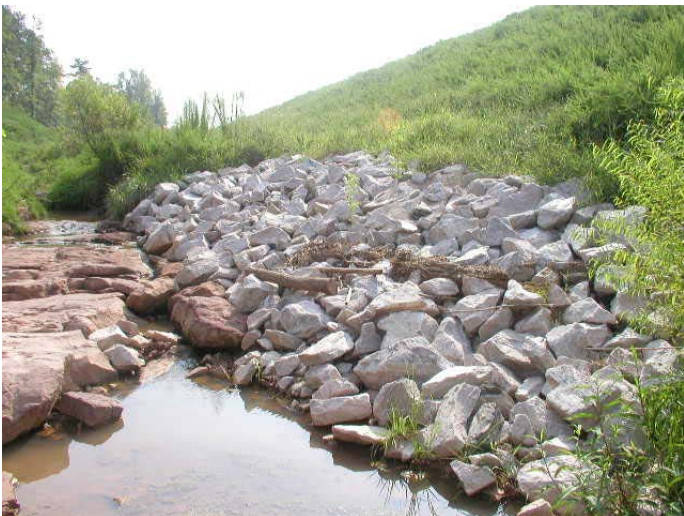
The stream is stabilized for the Year 2 summer evaluation. The bank erosion on the left bank at the inlet of the box culvert located at approx. Sta. 12+70 that was noted last during the last monitoring visit has been stabilized with rip rap with the Regulatory Agencies approval (last photo shows rip rap placed along left bank). The cross vane at approx. Sta. 10+50 that was noted during the last monitoring evaluation as being a destabilizing structure has been removed from the channel. This cross vane was causing the left bank to erode. NCDOT with the Regulatory Agencies approval felt that it was best to remove this cross vane due to the triassic rock located along the channel that would have made it impossible to re-stabilize this cross vane. The removal of this cross vane should not result in degradation of the relocated channel. There was evidence that a bankfull event had occurred since the last monitoring evaluation at this stream relocation. NCDOT will continue to monitor this stream relocation.

Rip rap placed along left bank at inlet of box culvert
